JURONG PORT SAFETY BULLETIN – JANUARY 2008 INCIDENT CASE STUDY#2: FALLING FROM HEIGHT

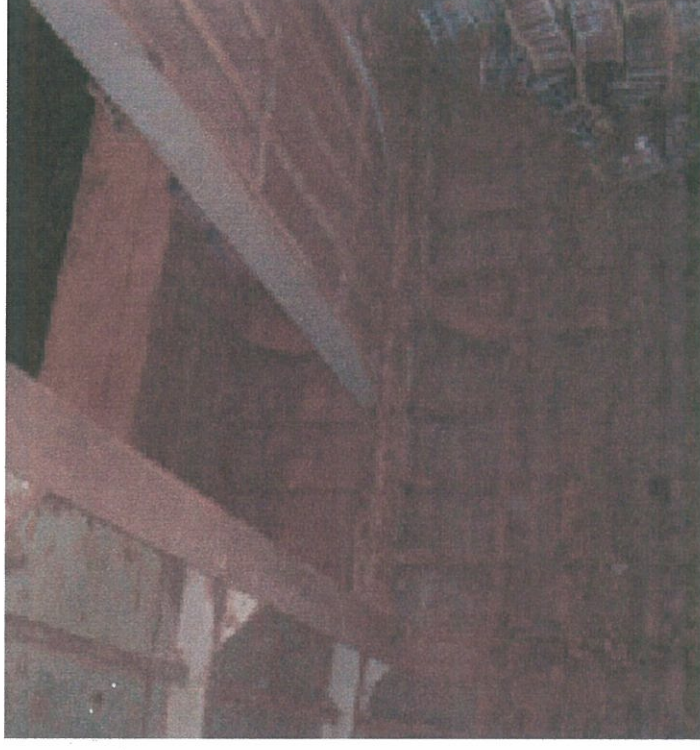
1. Inadequate guards/barriers. The injured worker fell through unguarded opening (missing hatch panel covers).
2. Inadequate Illumination. The workers claimed that the lighting near the opening is insufficient.

The injured worker fell from an opening in the twin deck. He suffered head injury.

1. Supervisor/Foreman to check worksite and rectify unsafe conditions before start of operation.
2. Conduct risk assessment based on worksite inspection and orientate workers.
3. Provide adequate lighting in worksites during night operations.
4. Keep an eye on the path while walking/working in hatches or cargo hold areas where lighting is inadequate.
