No.13 Of 2008

Reference No.: JPPL-FSS-SC-27022008-12

Jurong Port Pte Ltd
37 Jurong Port Road
Singapore 619110

SAFETY GUIDELINES ON INSTALLATION OF GANGWAY

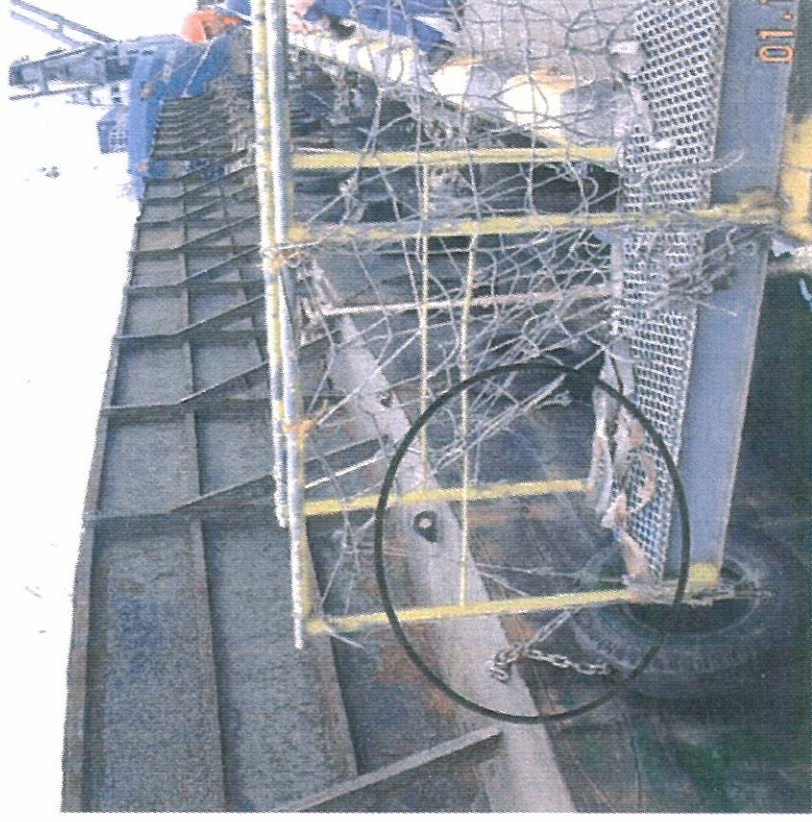
Gangway not properly secured.

Netting not properly installed.

- 2.1 Gangways are to be properly and steadfastly secured on both ends (i.e. wharf and barge/vessel's ends)
- 2.2 Gangways are to be wrapped/installed with safety netting throughout the length and/or Safe-all net installed right underneath the gangway to prevent workers from falling into the sea. Netting should cover both ends of the gangway especially at point of access and egress.
- 2.3 The safety and safe-all nets are to be free from defects and of good and sound construction that are able to hold/withstand human load.
- 2.4 Hand/guard rails of good and sound construction are to be installed throughout the length of gangway.
- 2.5 Guard Rails (Refer to attached illustration.)
 - 2.5.1 Uppermost guard rail ≥ 1.0 metre above walkway platform
 - 2.5.2 Gap between 2 guard rails < 600 mm

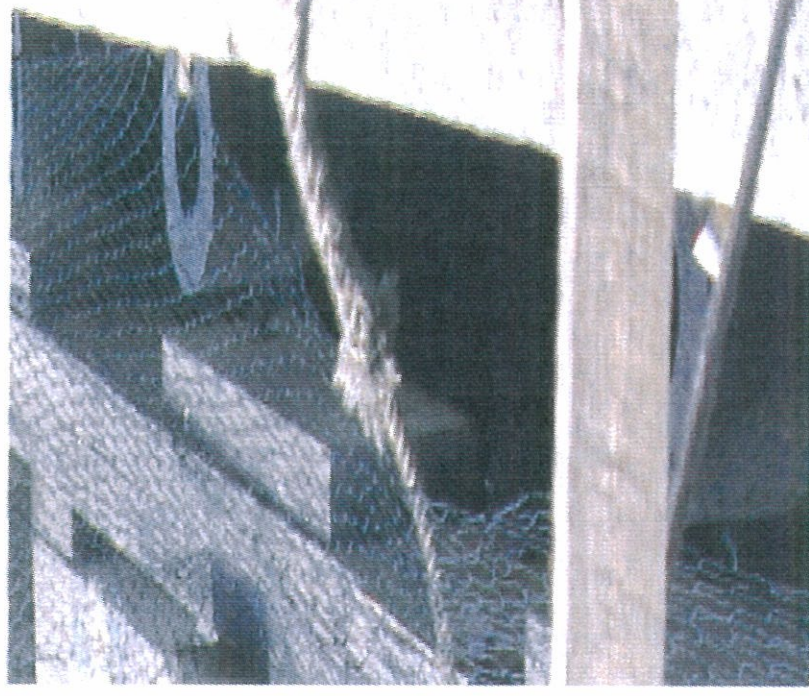
Sub-standard netting.

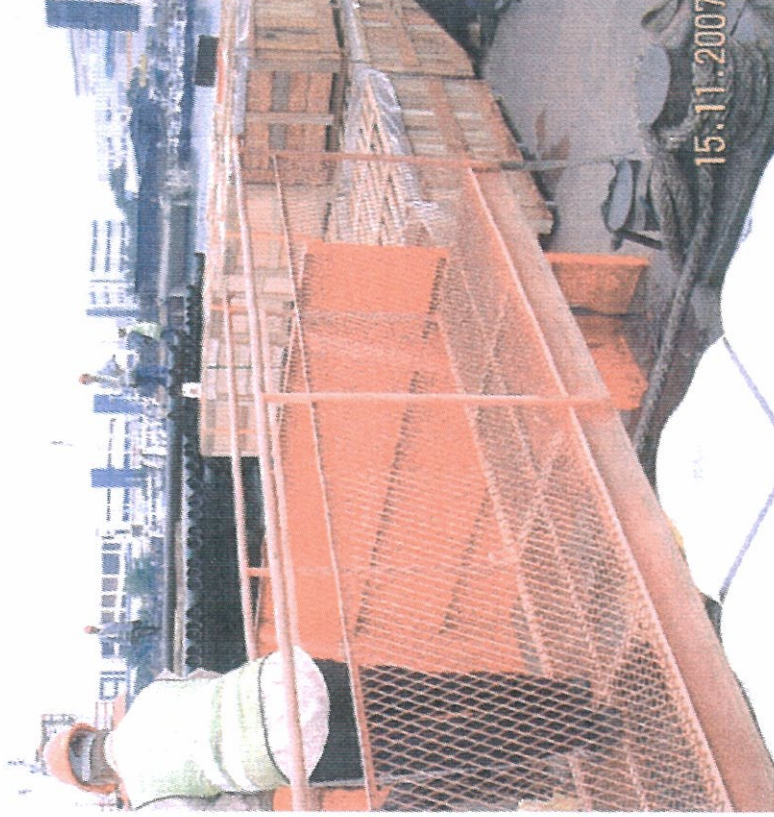
No step down platform for access and egress.

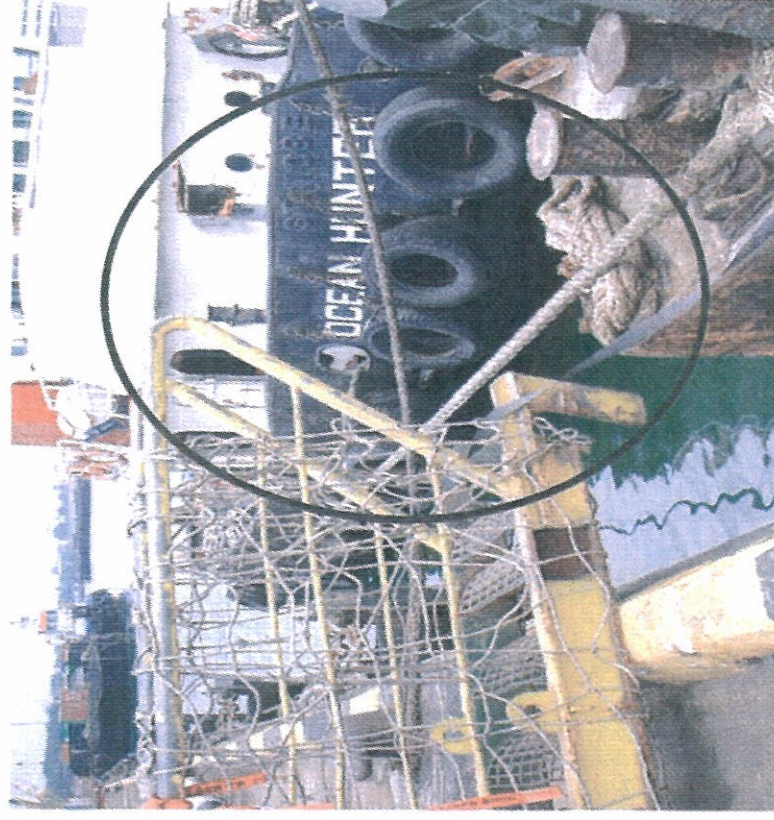
Gangway not extended fully to barge; improperly installed.
